**CASCADE BROOK DAM**

**NH 00082**

**PRELIMINARY INSPECTION REPORT  
NATIONAL DAM INSPECTION PROGRAM**

**DECEMBER 1980**

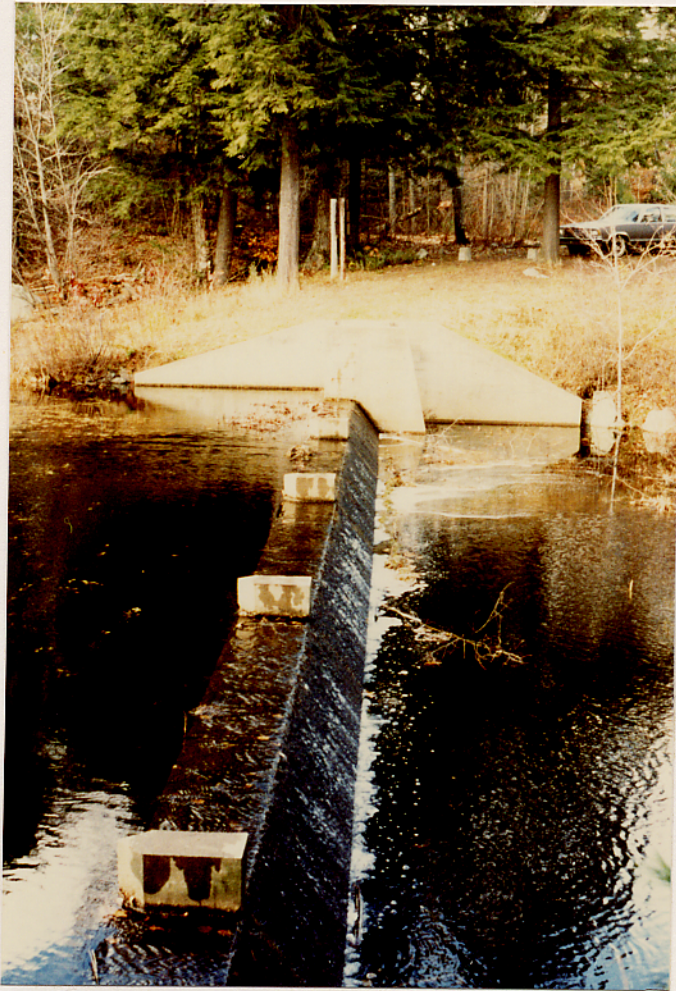
1. Spillway From Right Abutment - Note: No Flashboards in Place

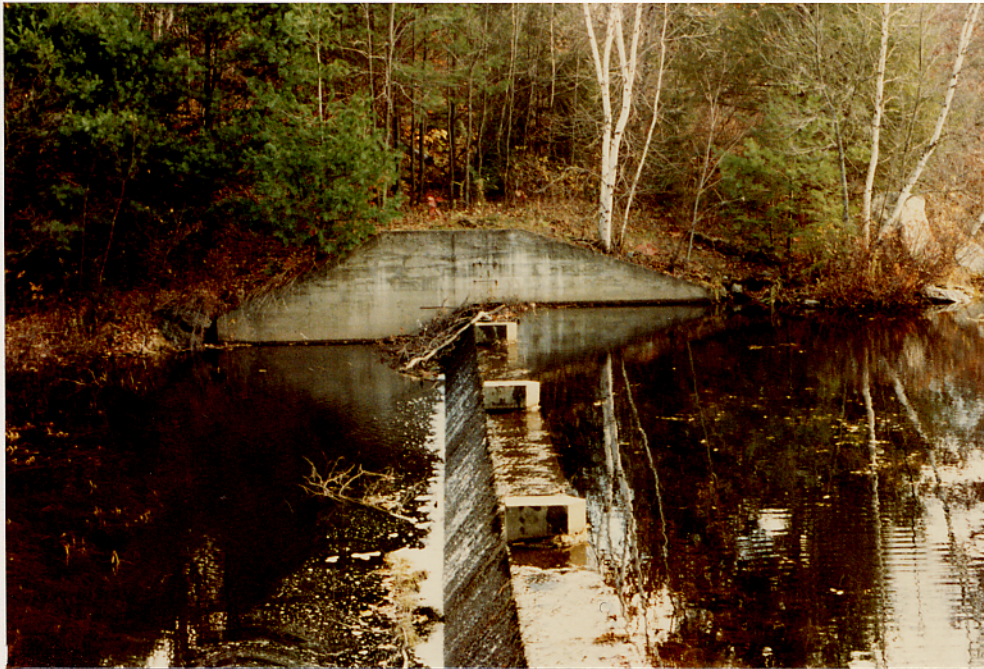
2. Spillway and Right Abutment

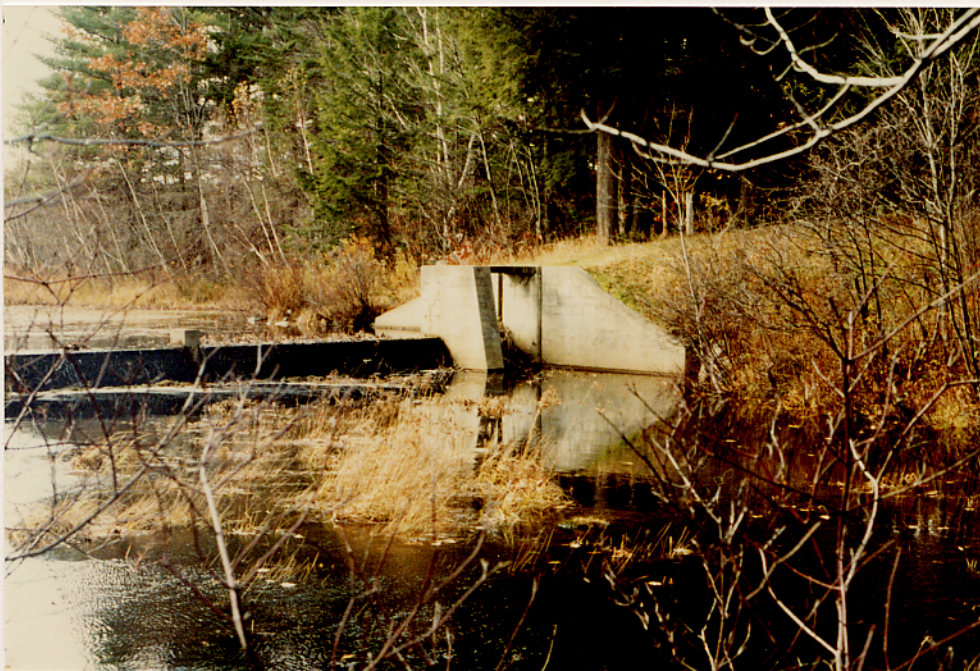
3. Left Abutment and Stoplog Bay

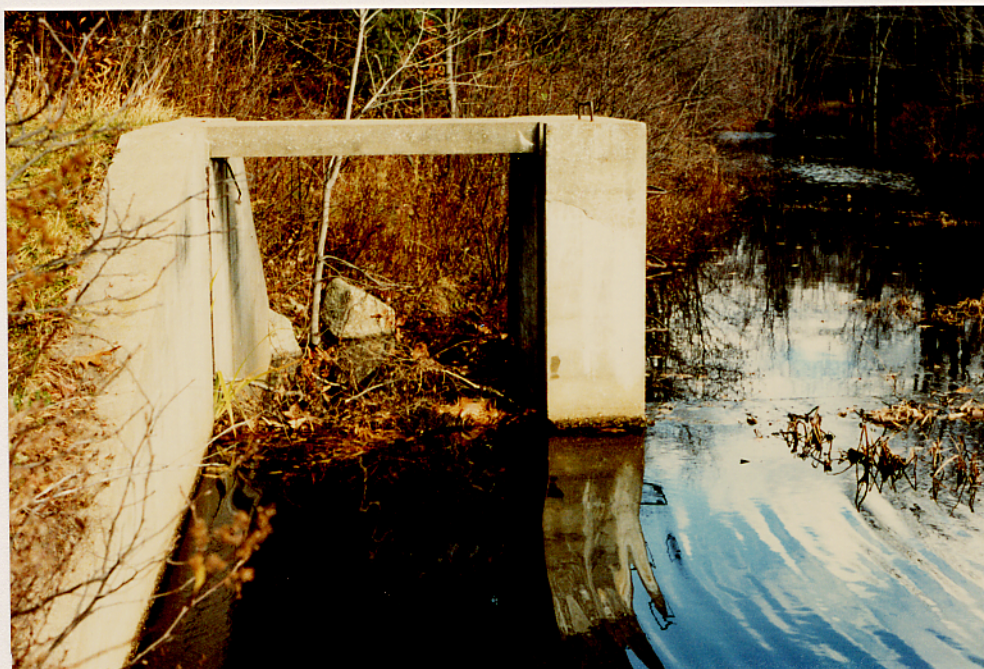
4. Stoplog Bay From Upstream - Note: Debris in Outlet

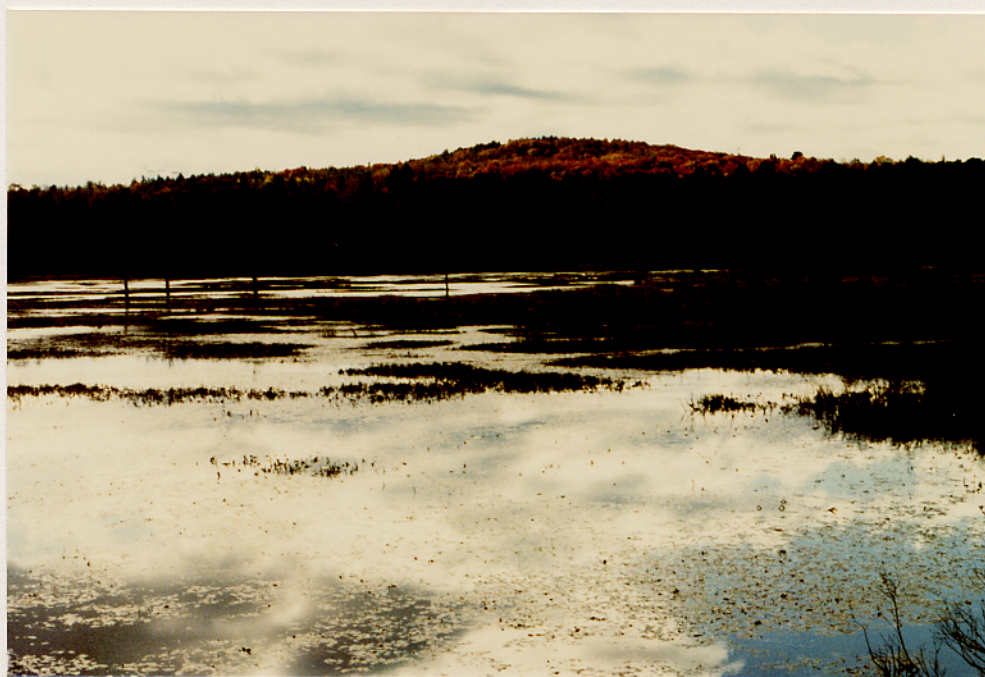
5. Reservoir Area
